Habitat Restoration in Southeast Michigan Areas of Concern: Detroit River, St. Clair River, River Raisin, Rouge River, & Clinton River

Melanie Foose & Jen Tewkesbury
Michigan Department of Environment, Great Lakes, & Energy (EGLE)

SCDRS Webinar
June 23, 2020

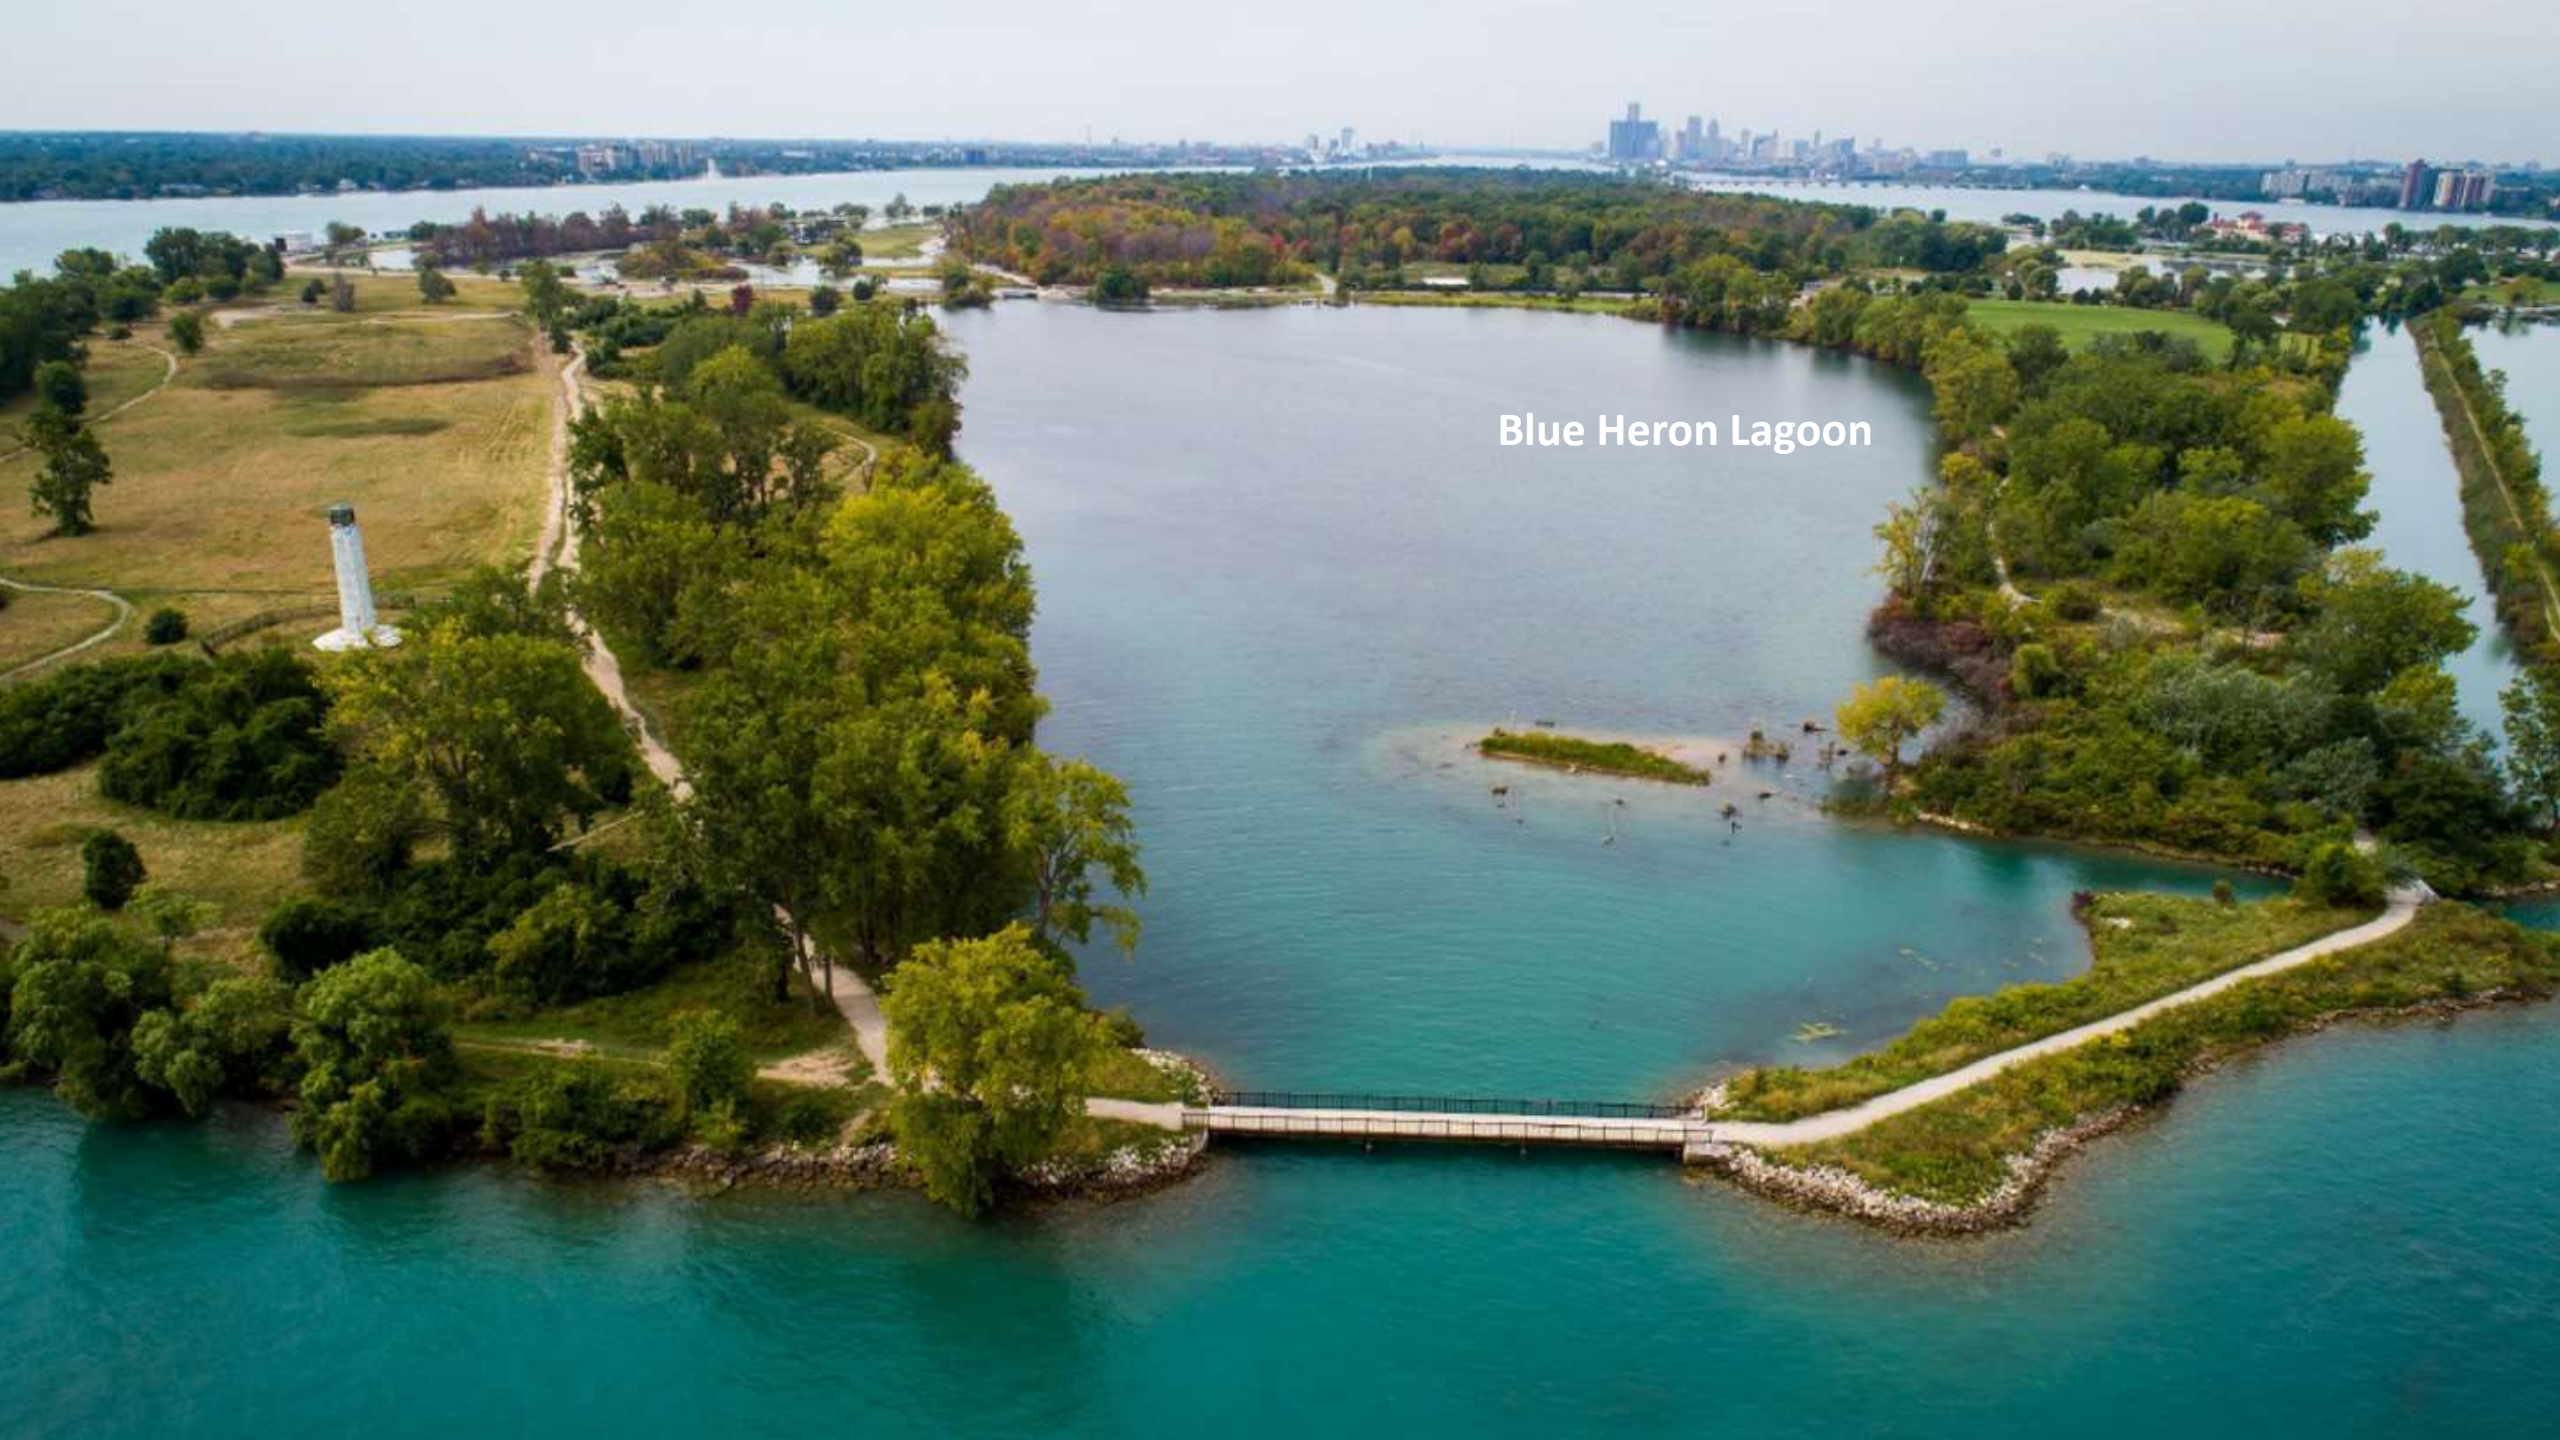
Blue Heron Lagoon

An aerial photograph showing a large body of water, Blue Heron Lagoon, in the upper half of the frame. A concrete dam with a black metal railing spans across a smaller, narrower body of water, Lake Okonoka, in the lower half. To the left of the dam is a paved parking lot with several cars. The surrounding landscape includes green grass, trees with some autumn-colored foliage, and a road. The water in the lagoon is a light blue-grey, while the water in Lake Okonoka is a darker, greenish-blue. The sky is clear and blue.

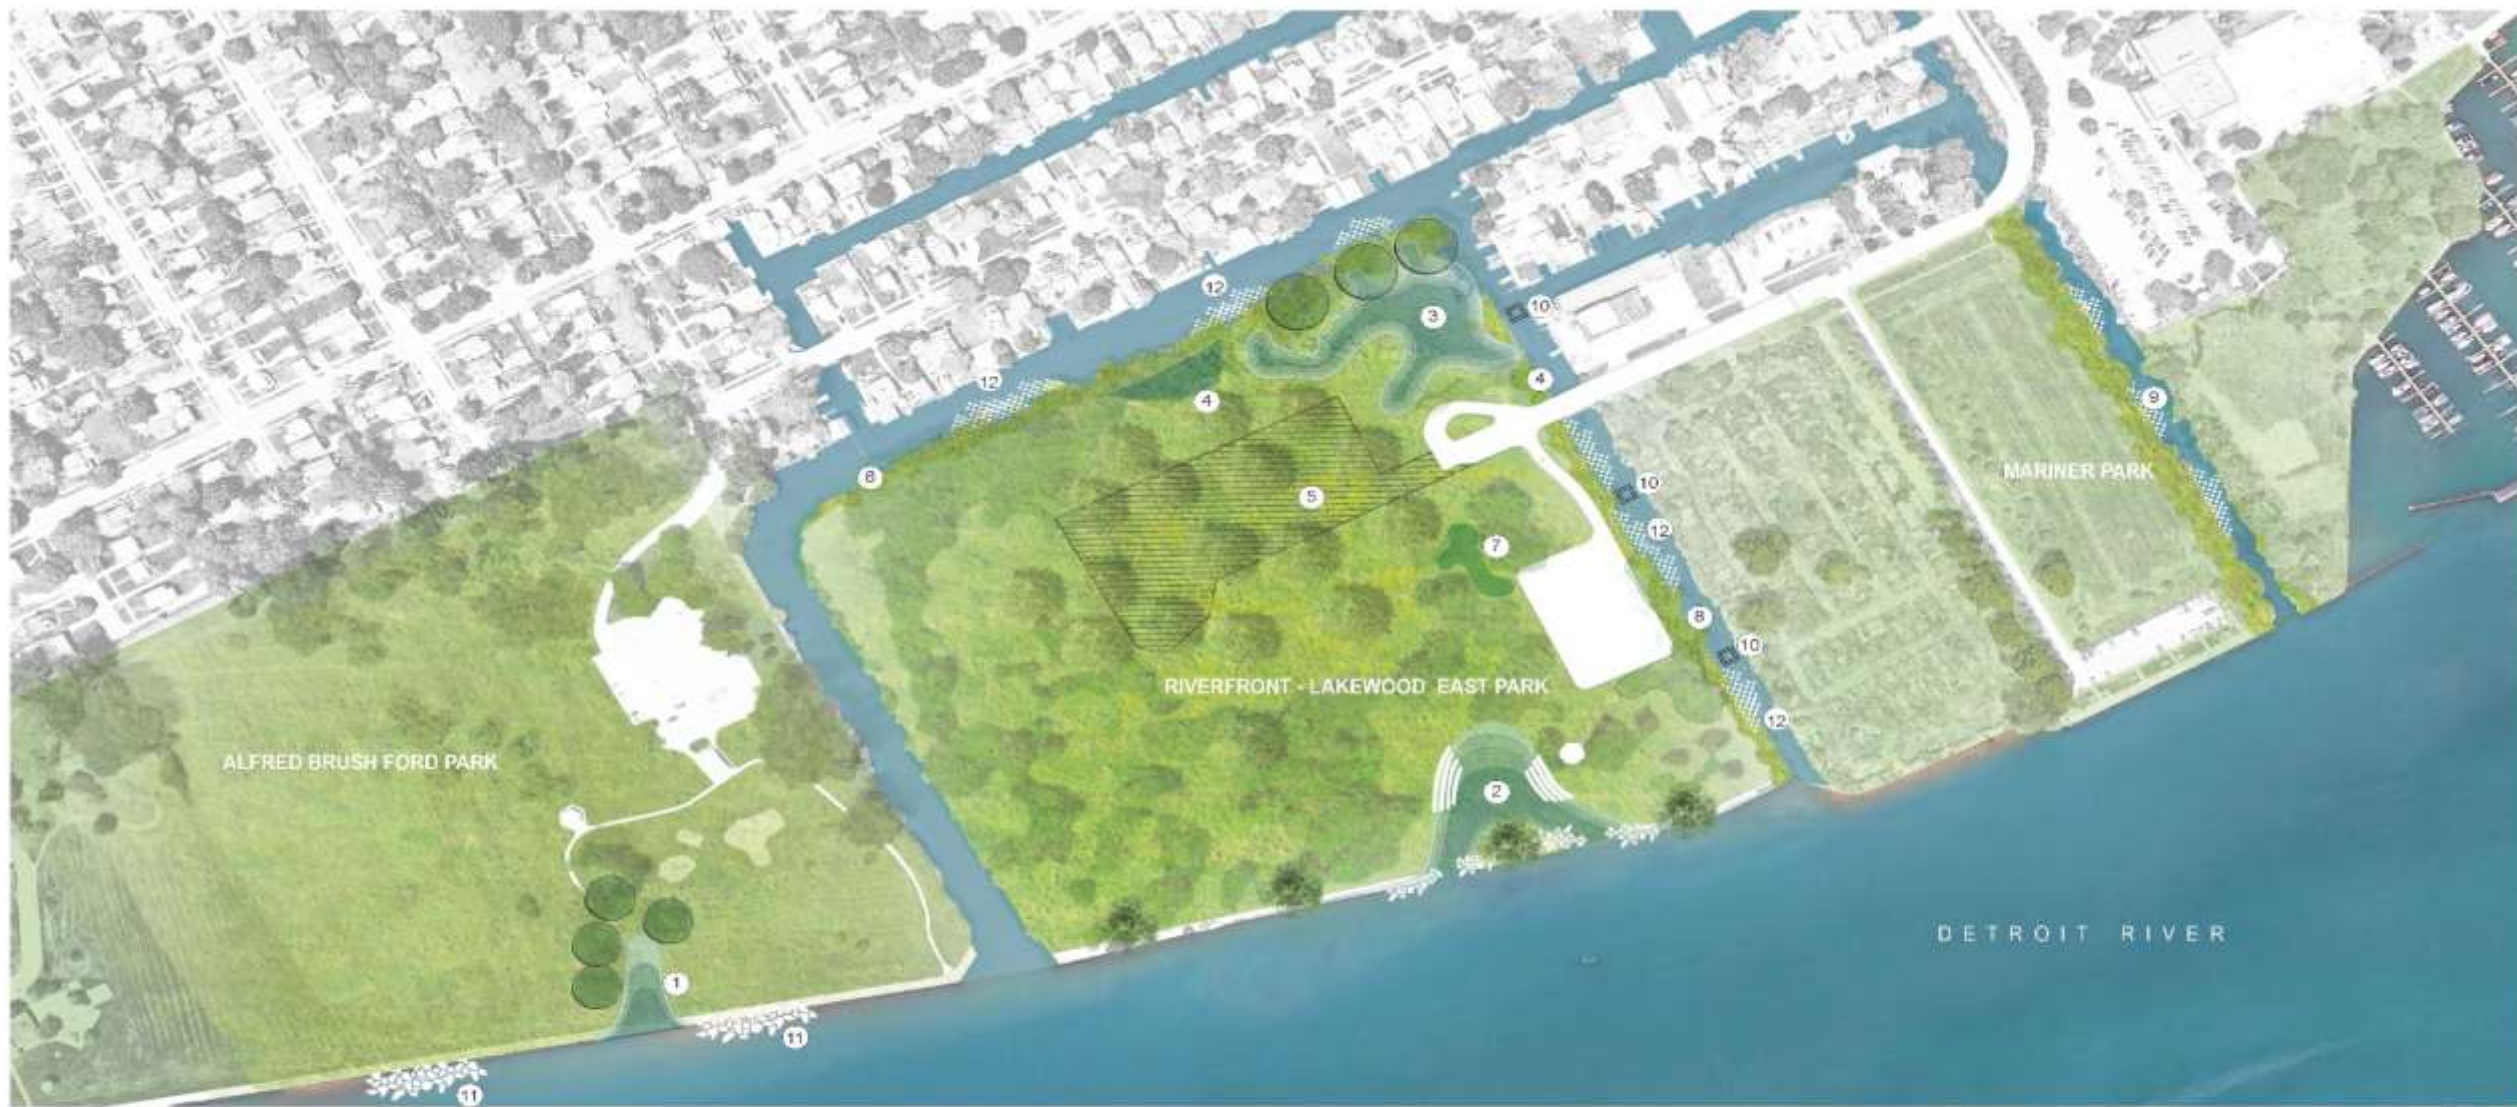
DETROIT UPPER RIVERFRONT PARKS HABITAT RESTORATION

- ① WETLAND AT AS FORD PARK
- ② WETLAND AT RIVERFRONT - LAKEWOOD EAST PARK
- ③ POCKET WETLAND ALONG CANALS
- ④ ENHANCEMENTS TO EXISTING WETLANDS
- ⑤ PARKING LOT REMOVAL & UPLAND PLANTING
- ⑥ UPLAND PLANTING / IMPROVEMENTS
- ⑦ POLLINATOR GARDEN
- ⑧ SHORELINE / RIPARIAN ENHANCEMENT IN CANALS
- ⑨ SHORELINE / RIPARIAN ENHANCEMENT AT FOX CREEK
- ⑩ FLOATING WETLANDS
- ⑪ SUBSTRATE ENHANCEMENT FOR FISH HABITAT IN DETROIT RIVER
- ⑫ SUBSTRATE ENHANCEMENT FOR AQUATIC HABITAT IN CANALS

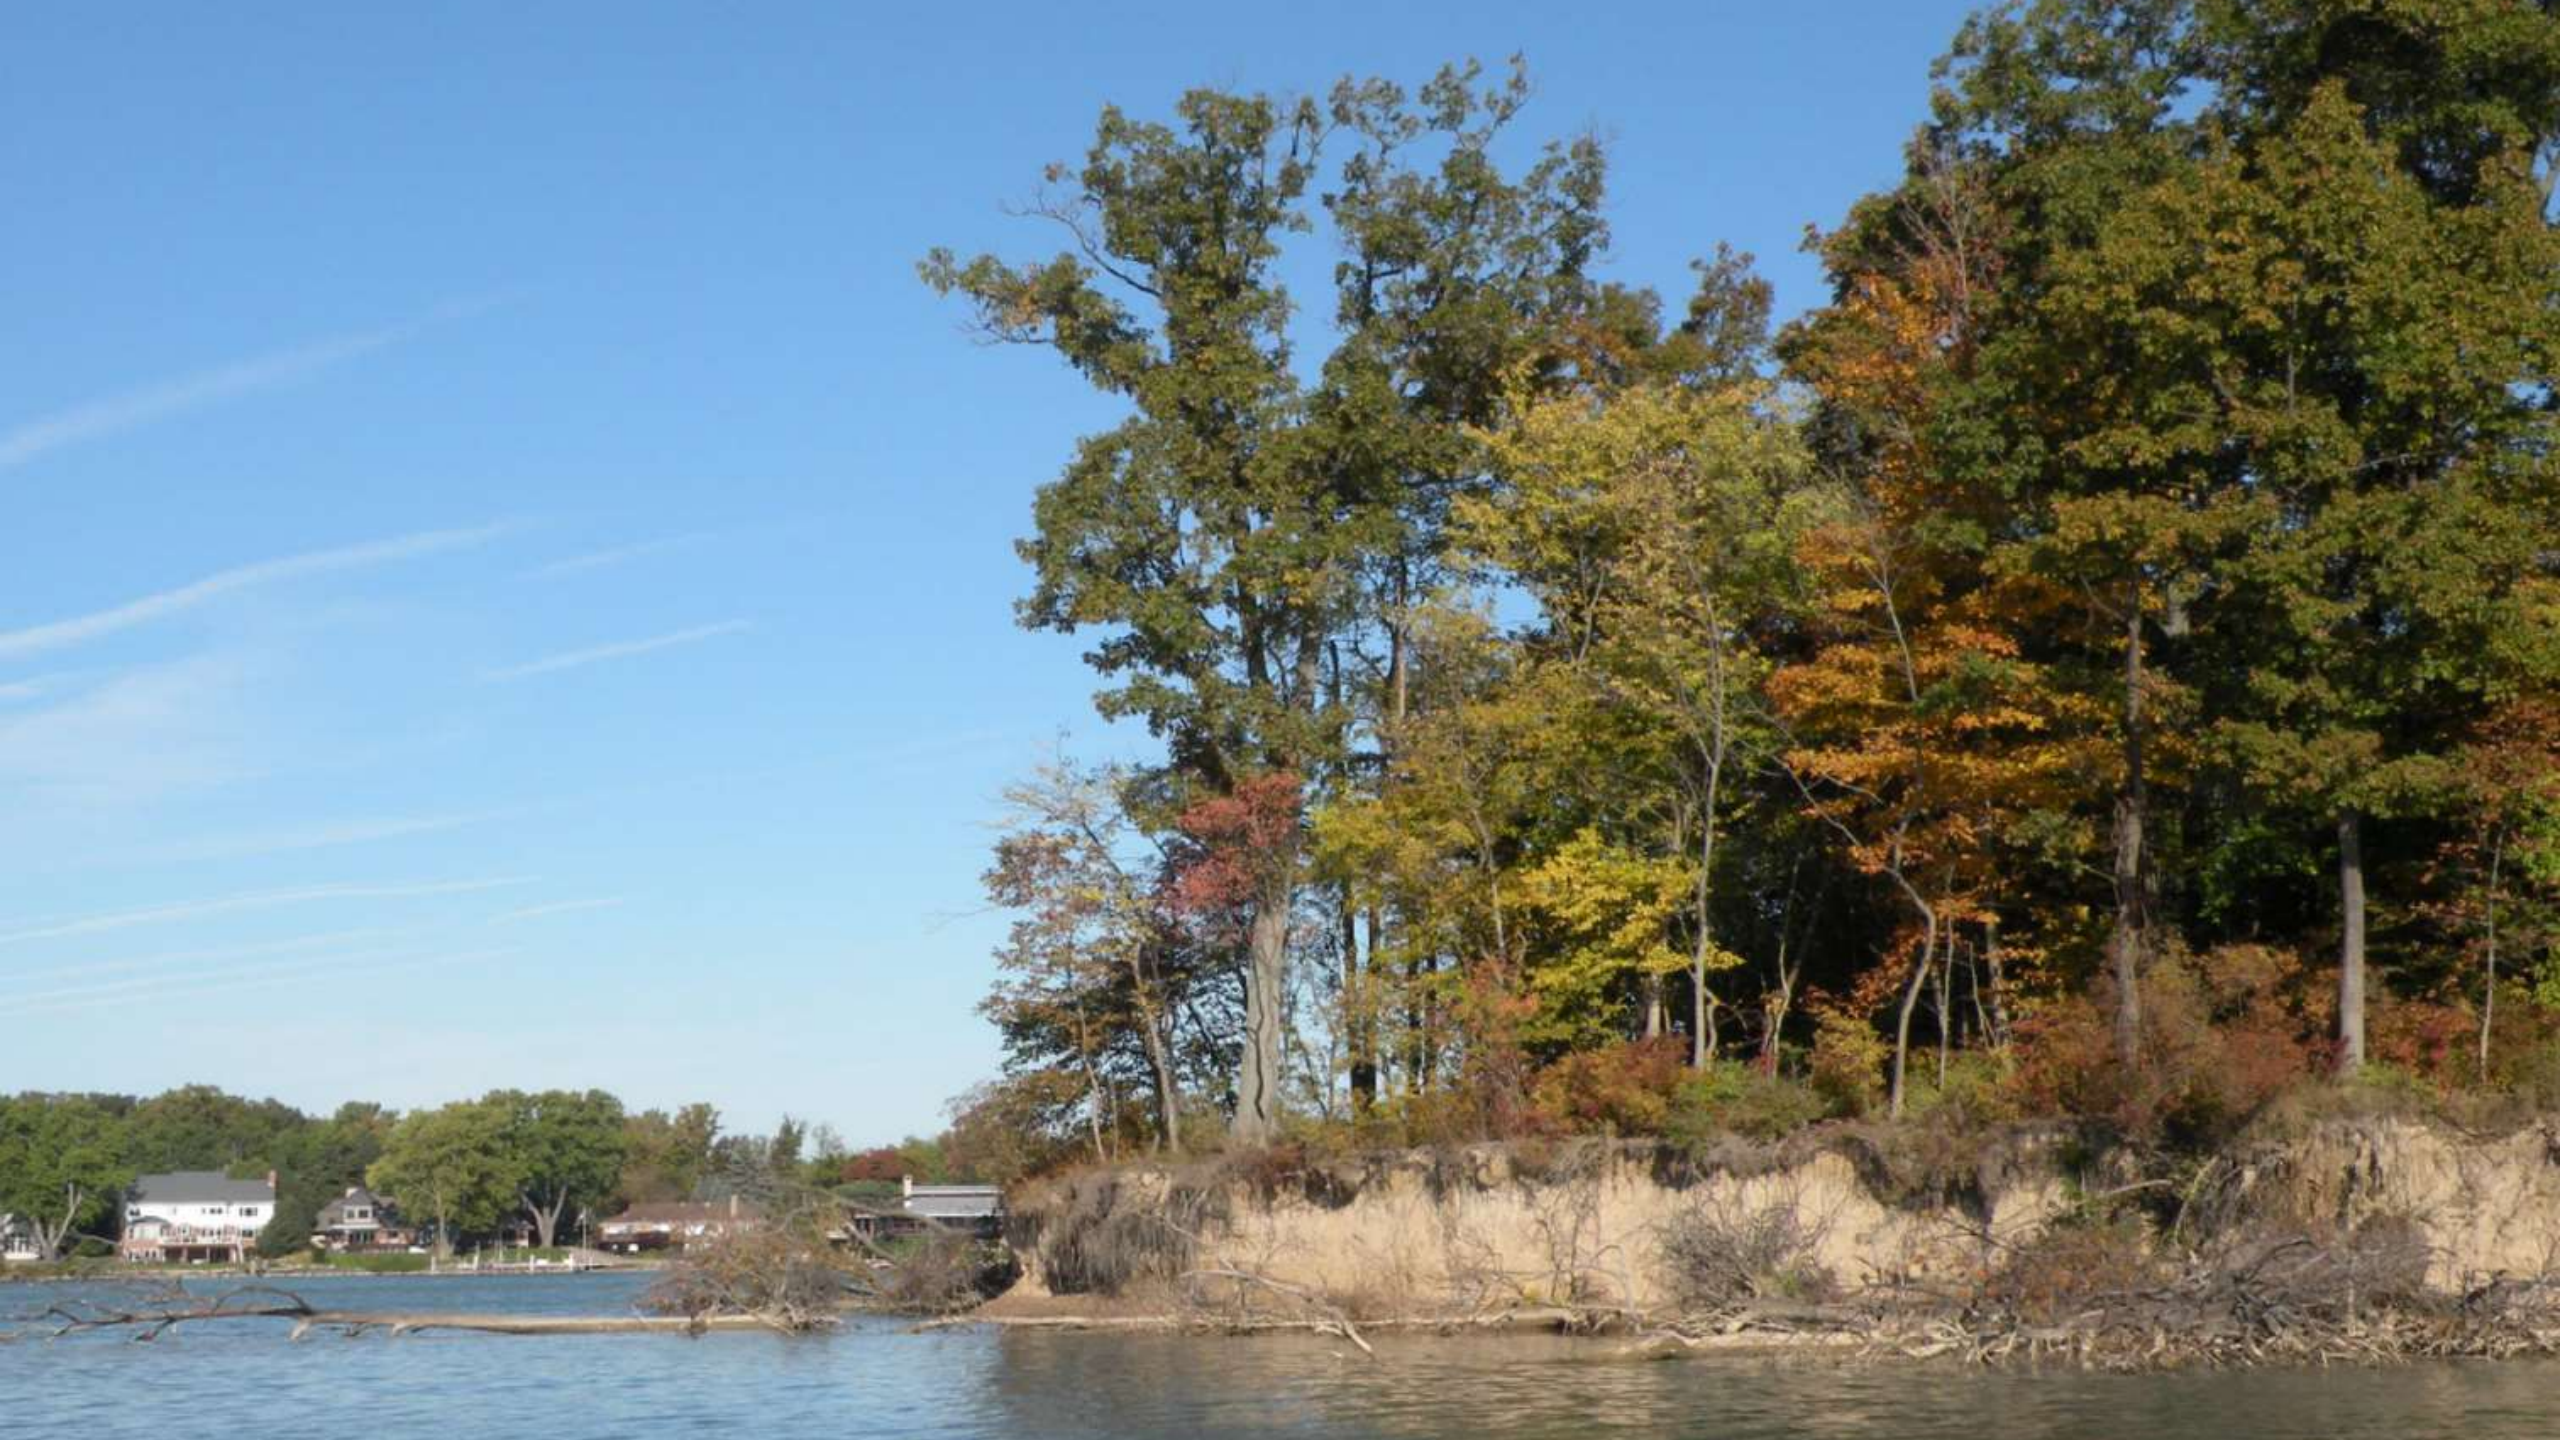
DATE PLOTTED:
OVERALL LAYOUT &
MATERIALS PLAN

- PROPOSED 100-YEAR CONTOUR
- PROPOSED 500-YEAR CONTOUR
- PLANTING AREA
- WOOD
- COARSE WOODY CEILING - RAISED & BOLTED
- COARSE WOODY CEILING - ANCHORED
- ROCK CHIPPING FOOT
- ADJUSTABLE SPINNING BEE
- STONE SLOPE
- WOODY SPINNING STRUCTURE
- SUBMERGED ROCK SLAB STRUCTURE
- STONE MASONRY/CLUM
- ROCK BOUND

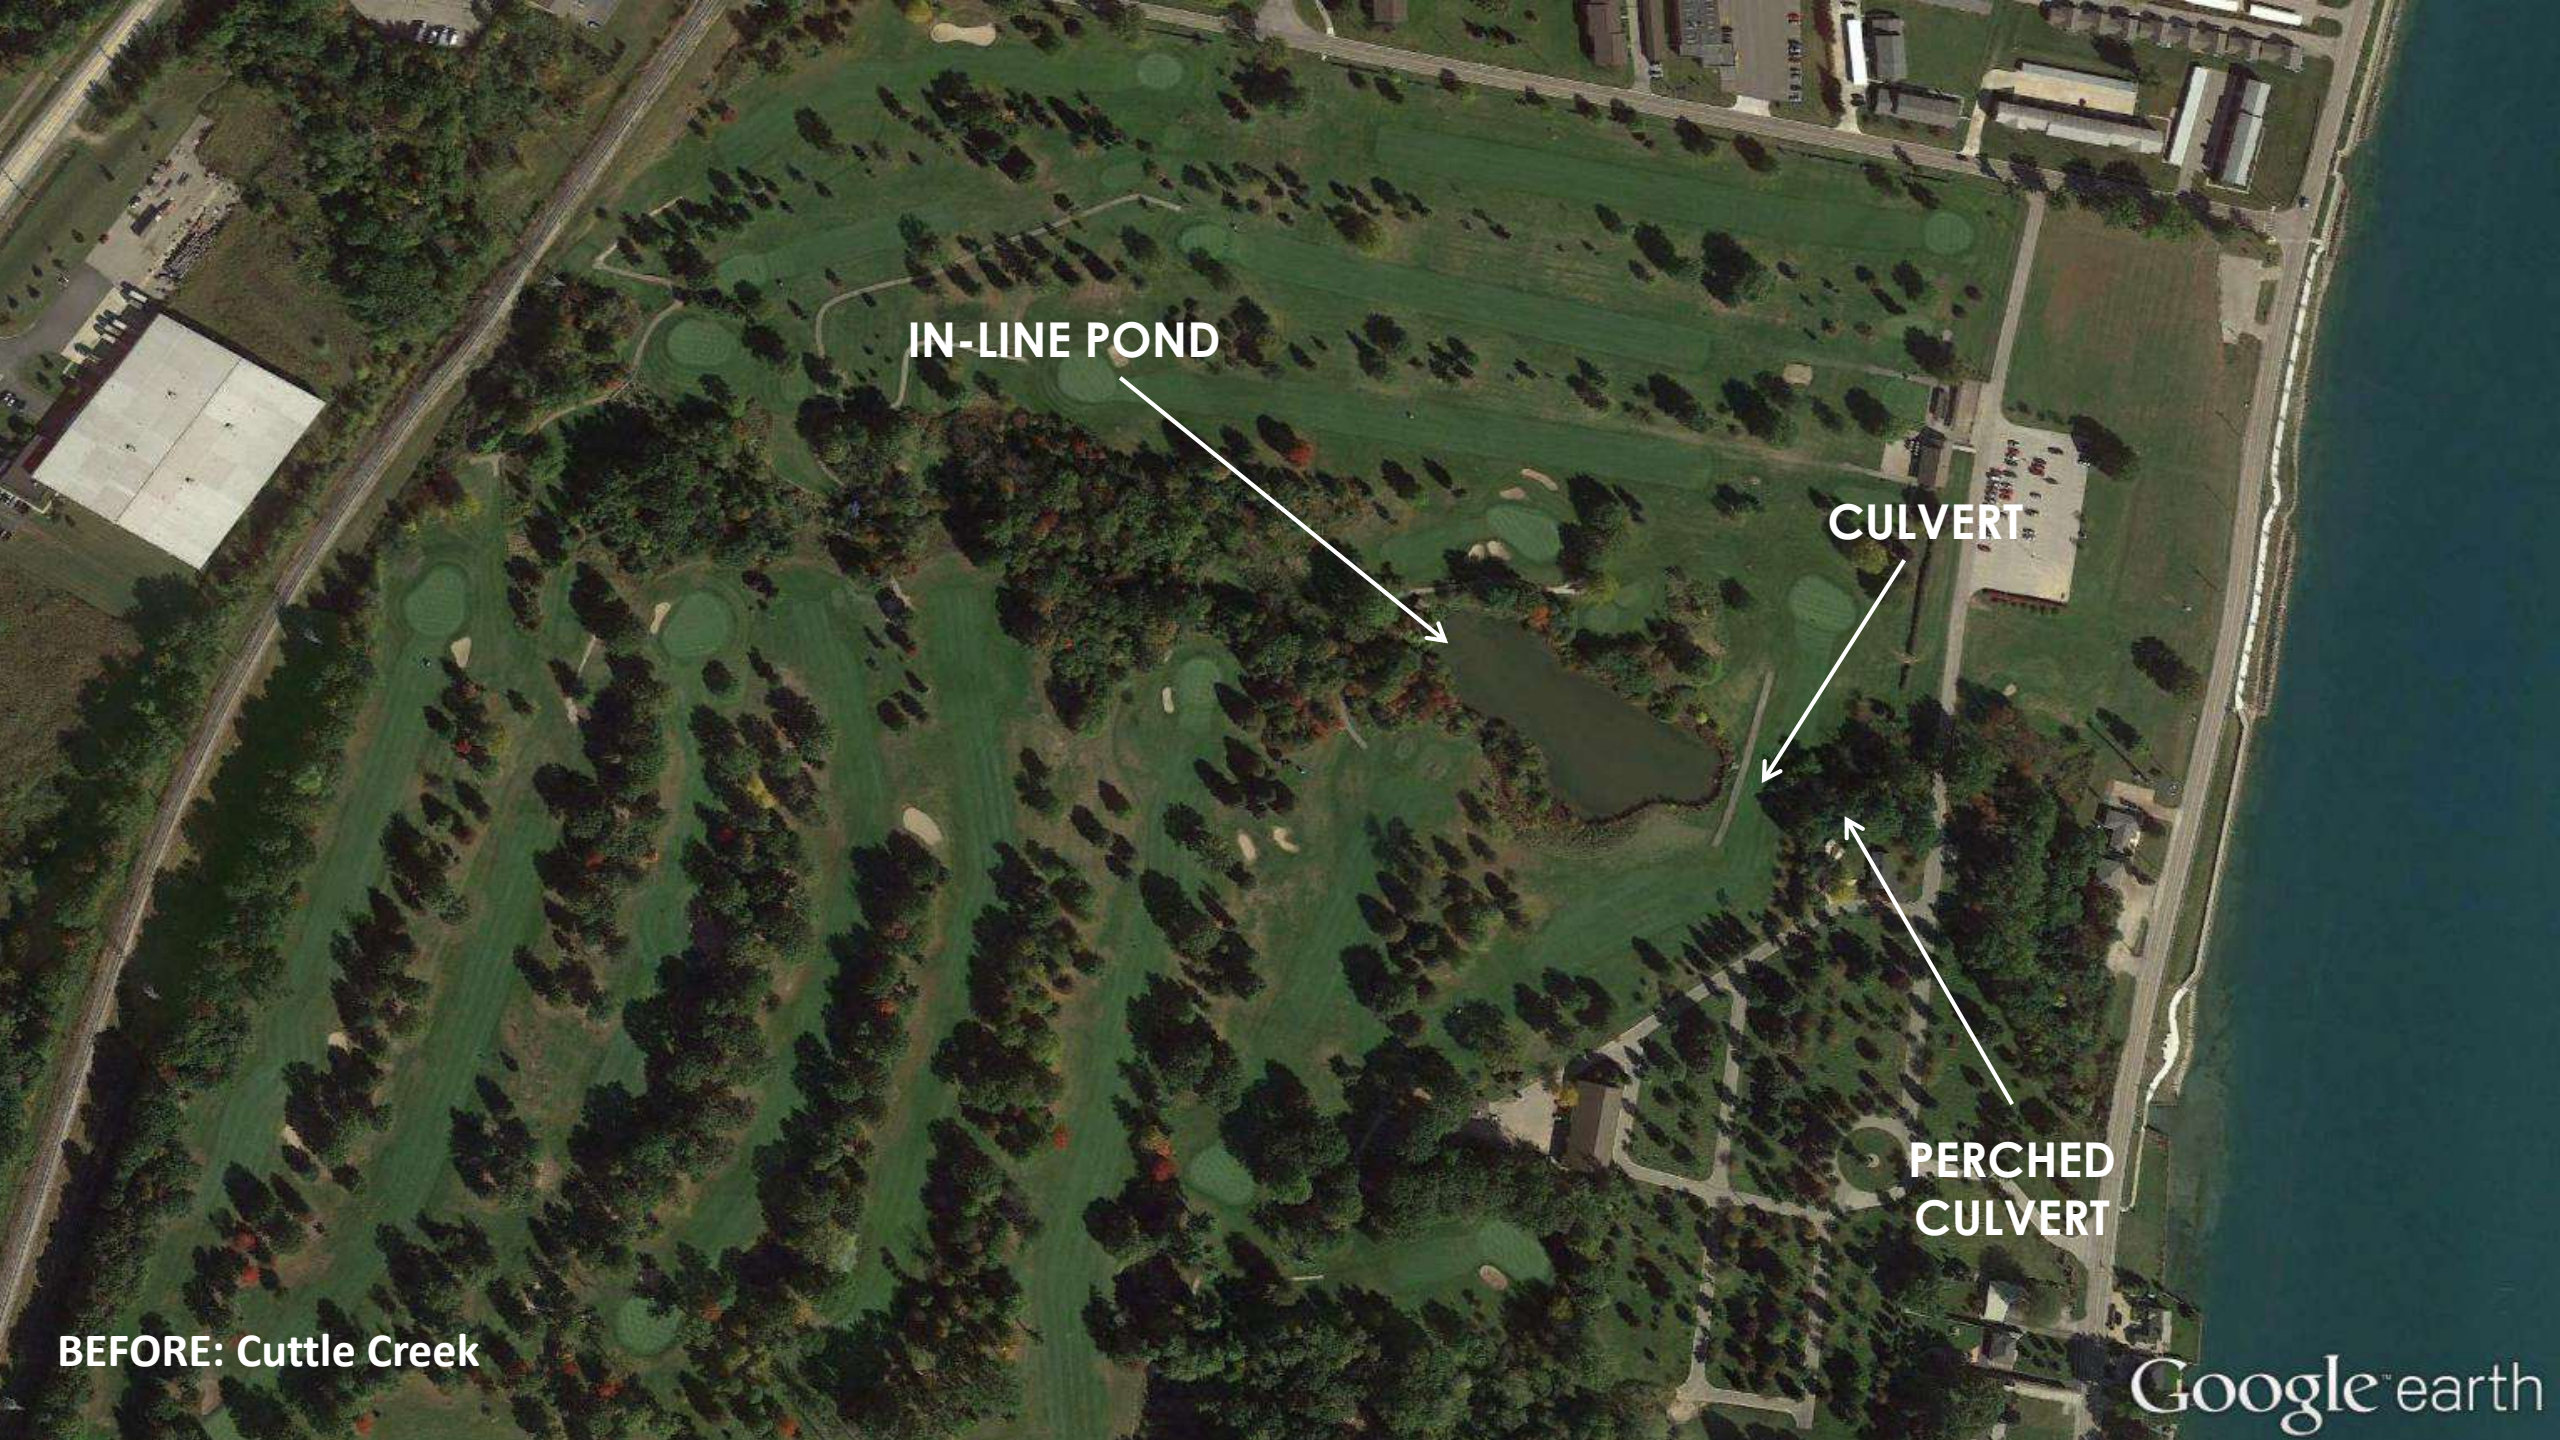
BEFORE: Cuttle Creek

IN-LINE POND

CULVERT

**PERCHED
CULVERT**

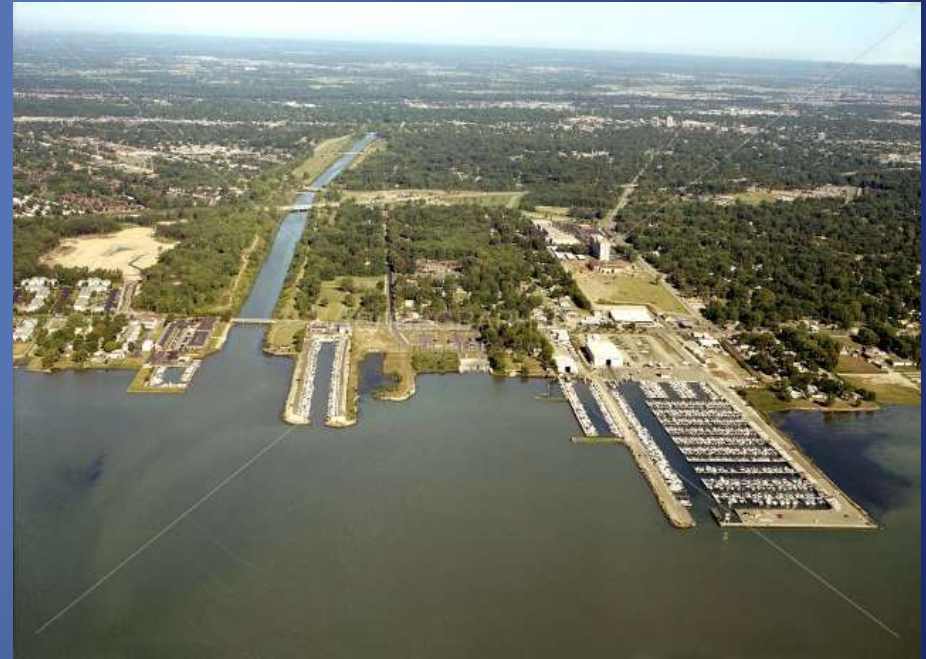
Clinton River Spillway Habitat Restoration

Habitat restoration and invasive species control including the Lake St. Clair estuary, riverbanks, nearbank areas, riparian corridor, floodplain and off-channel habitats which provide diverse fish spawning, rearing, and refuge habitats for northern pike, yellow perch and a variety of warm and coolwater species.

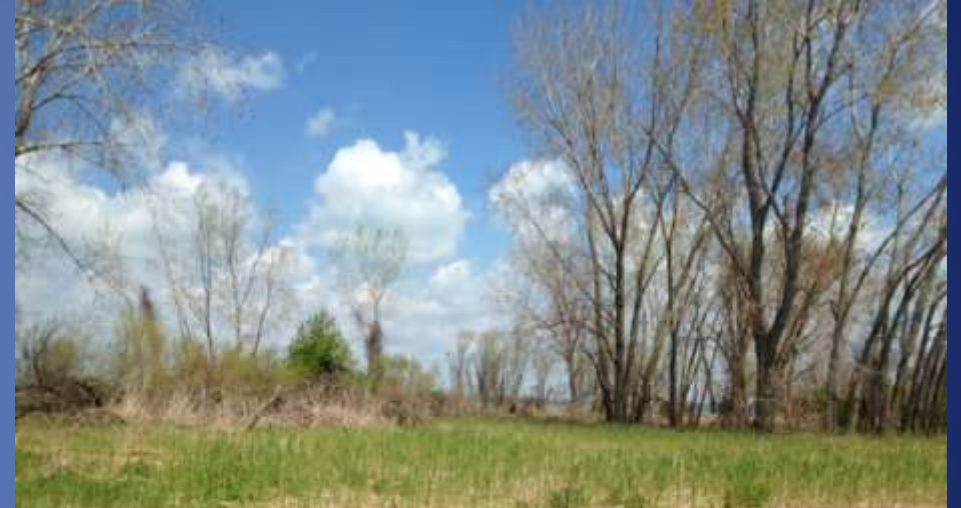
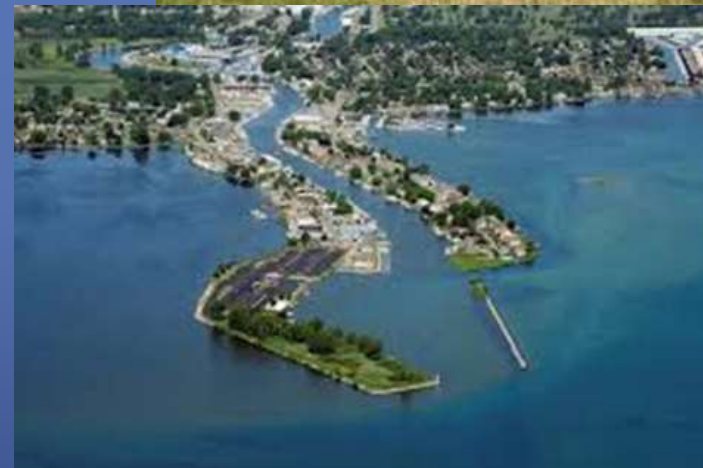
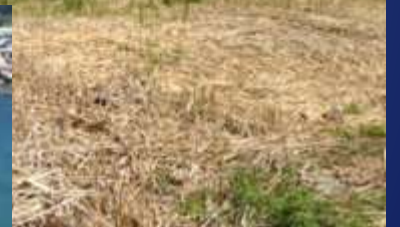
Clinton River Mouth/Harley Ensign Coastal Wetland Restoration

Control of invasive species, establishment of 14 acres of fish habitat, and restoration of 4 acres of upland habitat as well as 6,000 feet of shoreline. Provides nursery habitat for fish and stopover habitat for migrating birds.

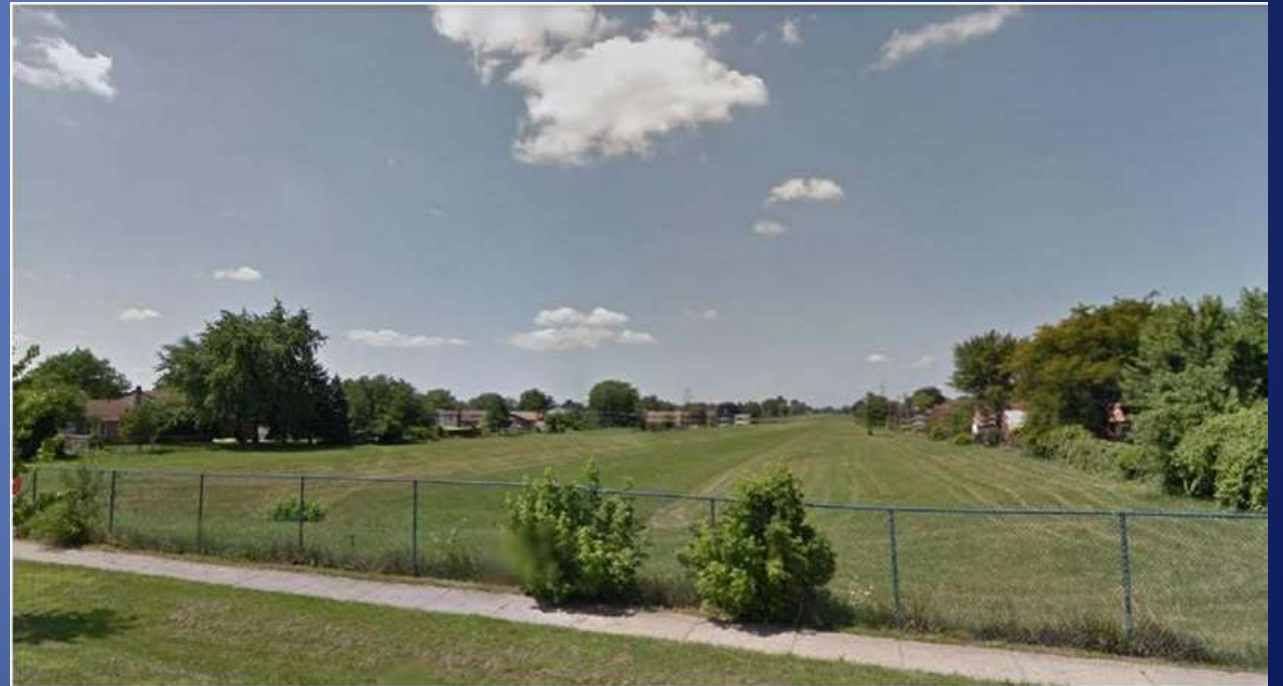
Sterling Relief Drain Daylighting and Green Infrastructure Phase I

Daylighting of the drain and implementation of green infrastructure. Creation of diverse natural habitat zones across the 250ft wide drain corridor to restore the natural processes that remove and breakdown contaminants and pollution from urban runoff, while creating an uninterrupted natural corridor.

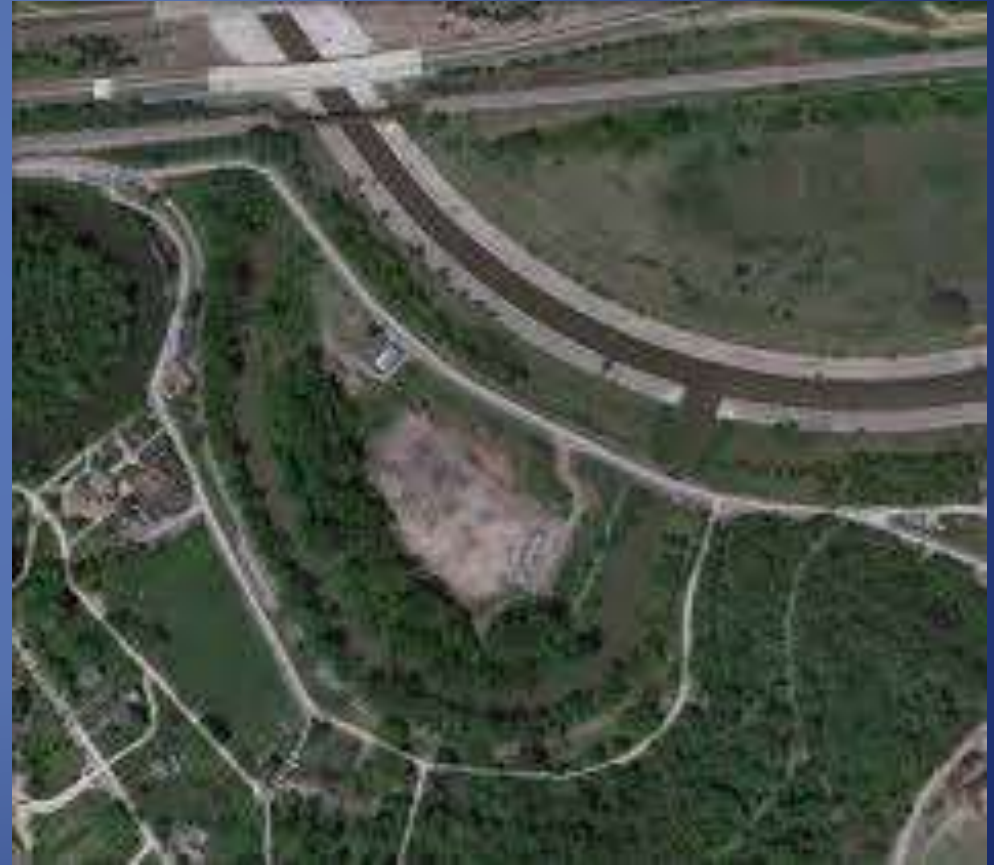
Rouge River Oxbow Restoration

- The purpose of the project was the reconnection of the Rouge River Oxbow segment to the main Rouge River channel at Greenfield Village through the construction of inlet and outlet openings. During the mid-1970s, Corps flood control efforts channelized the river, cutting off the oxbow and eliminating flood plain wetlands and habitat.

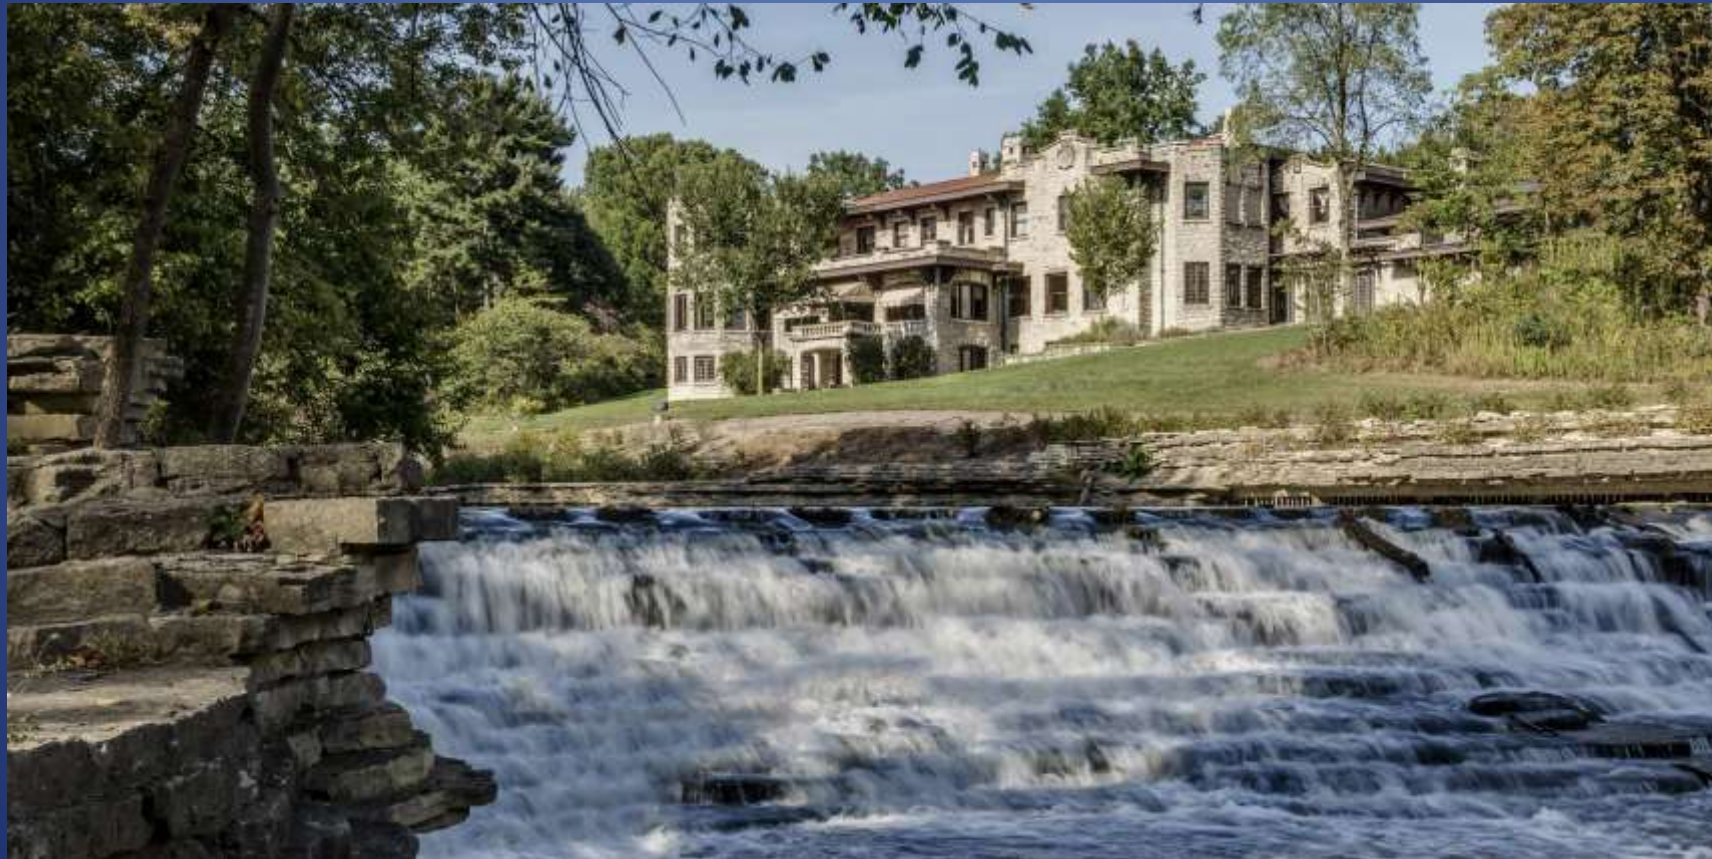
Henry Ford Estate Fish Passage

- The dam at the Henry Ford Estate is located on the middle branch of the Rouge River just upstream from its confluence with the lower branch of the Rouge River in the City of Dearborn.
- The dam, a National Historic Landmark, is the 1st dam upstream of the mouth of the Rouge River blocking fish movement from the Detroit River upstream into potential spawning and foraging habitat in the Rouge.
- Fish passage around the dam reconnects segments (18-36 miles) of the Rouge for the benefit of fish and other wildlife.

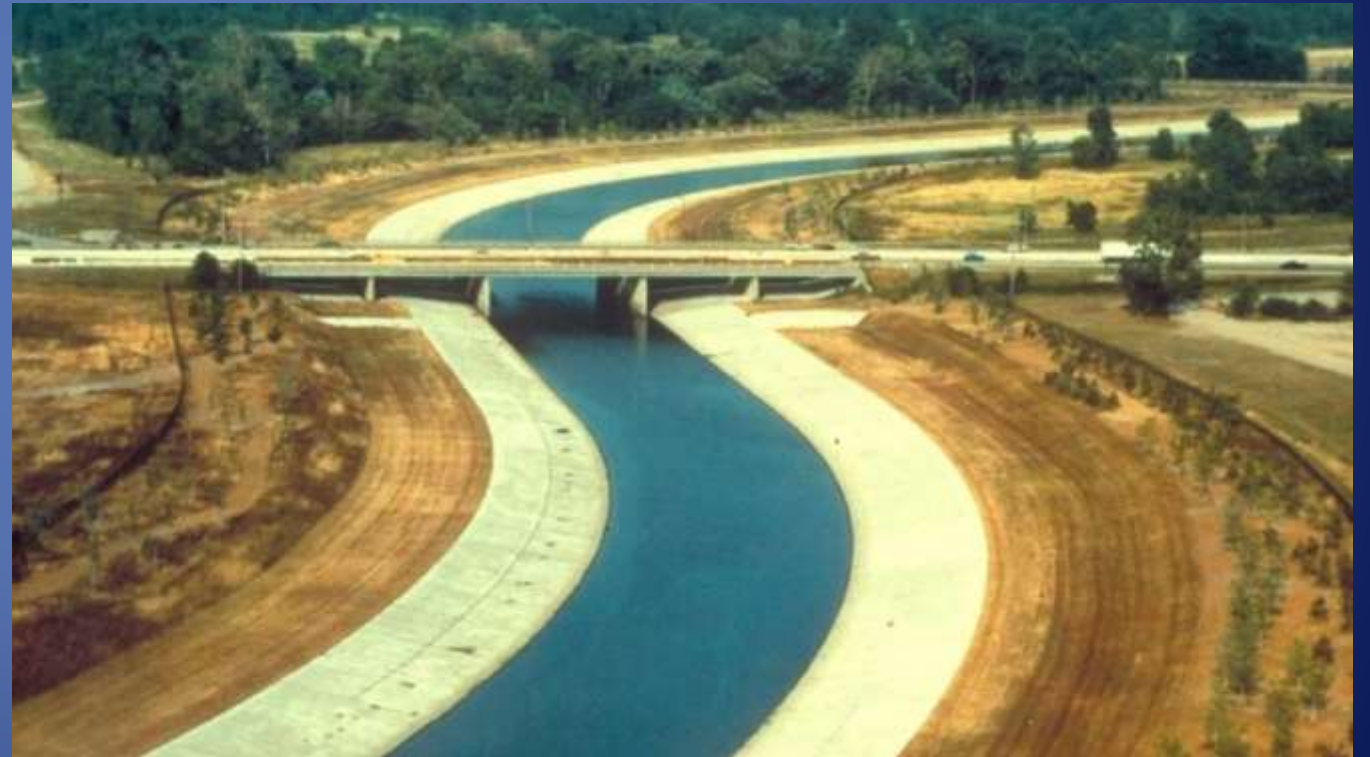
Rouge River Concrete Channel Habitat Enhancement

- Initial habitat assessment completed by USGS 2019
- U.S. Army Corps assessing habitat possibilities within and around the channel
- Main focus will be suitable conditions for fish to rest and spawn while also maintaining flood control
